TEM AND SEM (EBIC) INVESTIGATIONS OF SILICON BICRYSTALS

Quarterly Report

JPL Contract No. 956046, Report #17

R.Gleichmann and D.G.Ast

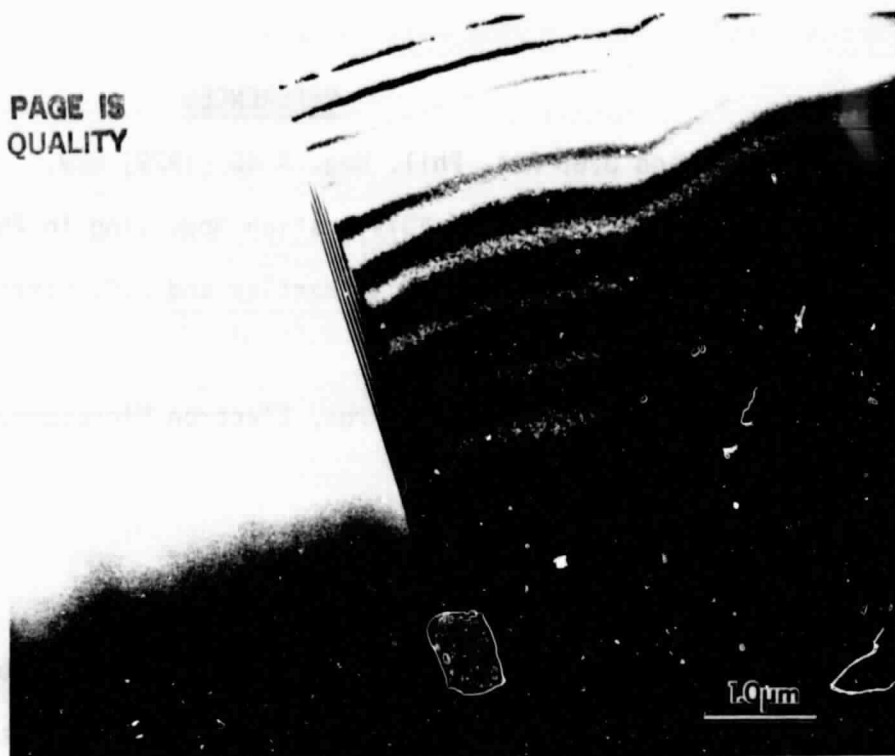
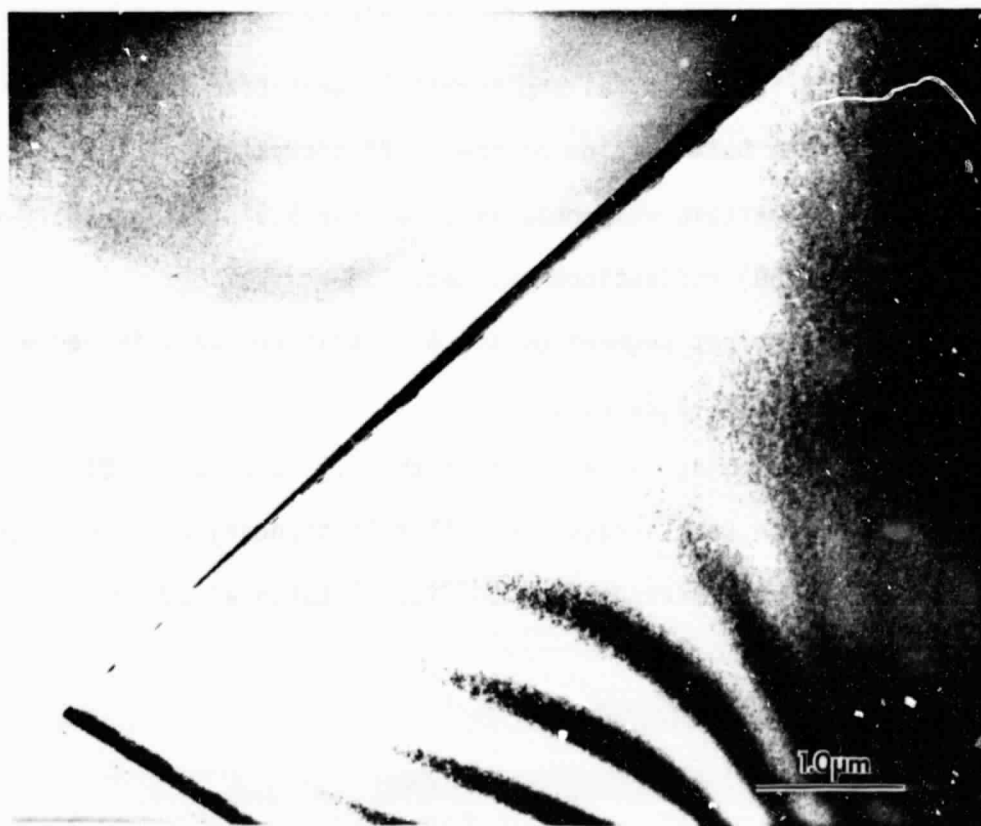
- Fig. 1. Brightfield TEM micrographs of the 17.2° tilt boundary, taken from several TEM specimen prepared from the bicrystal (tilt axis $[100]$).
- Fig. 2. Determination of the orientation relationship of the 17.2° boundary by convergent beam diffraction.
- Fig. 3. EBIC micrograph of the 17.2° tilt boundary at 20 keV.
- Fig. 4. Brightfield (a) and darkfield weak-beam image of the dislocations in the bulk section of the 17.2° bicrystal.
- Fig. 5. Darkfield weak-beam image of the 5.5° tilt boundary with the common (100) reflections excited.
- Fig. 6. Straight segment of the 5.5° tilt boundary imaged with EBIC, beam energy is 20 keV.
- Fig. 7. Dissociation reaction of the 5.5° boundary (EBIC, 30 keV).
- Fig. 8. Line scan across the 5.5° tilt boundary with corresponding zero line (area corresponding to Fig. 6) taken at 30 keV.

TEM allows only the inspection of short pieces of the boundary which, at most, some ten micrometers in length. Within these limitations, the 20° boundary was found to be surprisingly straight, homogeneous and free of extrinsic dislocations. These features can be seen in the brightfield images of different parts of the boundary - Fig. 1. Since the density of the intrinsic dislocations is expected to be high with spacings in the order of 18 \AA , it was not surprising that individual dislocations could not be resolved even in weak-beam micrographs.*
